Technical Bulletin #23

FMCSA - Information Systems

Subject: Configuring ASPEN v1.5x to communicate with the new SAFER System Server (aka: >Appendix H= of the FMCSA Field Systems CD Release May 21, 2001)

Date: June 21, 2001

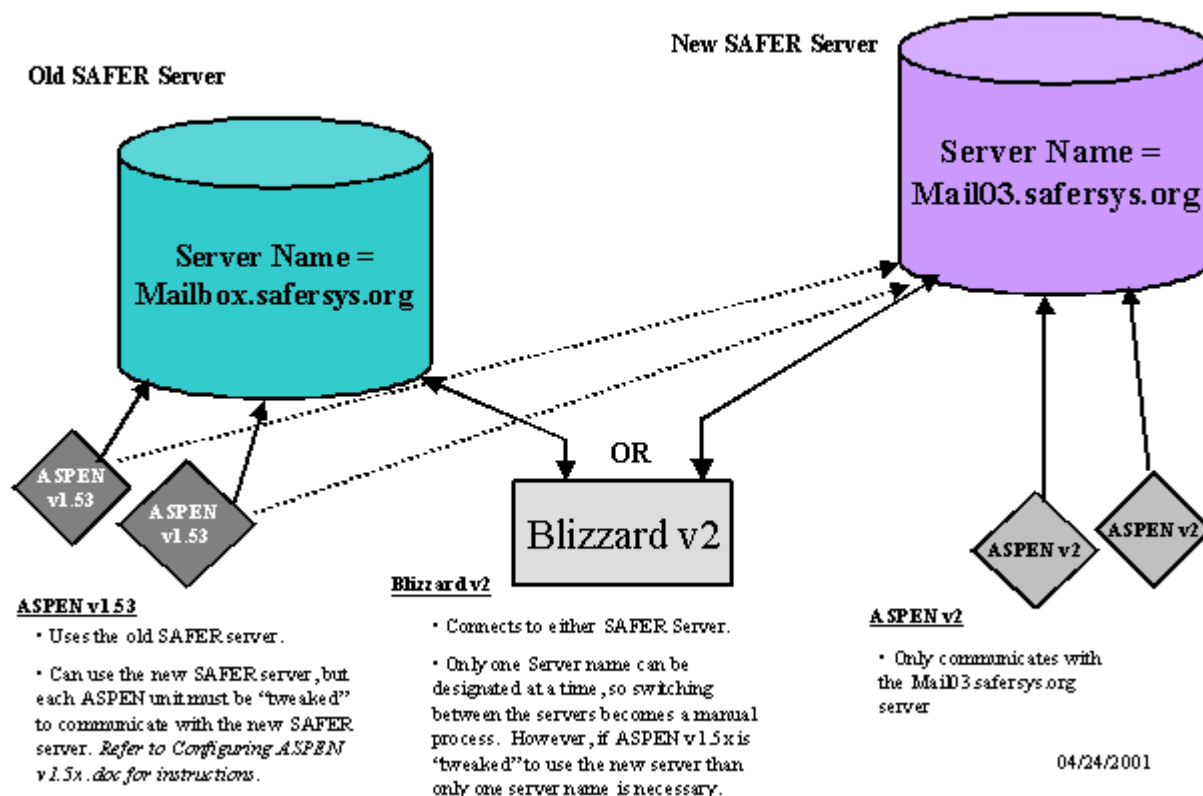
Configuring ASPEN v1.5x to work with the new SAFER server

Below is a diagram visually explaining the SAFER server change:

- 1) Using your Windows Find file function, locate the following file: S16config.exe (Normally this file can be found in: c:\fsgshare\saferglu\)
- 2) Execute this file by double-clicking.
- 3) Change the first path (Server In-Box) to: safersys.org (should be default, but verify it).
- 4) Click the Quick Copy button located under the file paths.
- 5) Make sure the message retrieval selection is Retrieved high numbered messages first (this is the default, but verify anyway).
- 6) Click OK.
- 7) Using your Windows Find file function, locate the following file: saferglu.exe (normally this file can be found in c:\fsgshare\saferglu\).
- 8) Execute this file by double-clicking.
- 9) Select the file menu option.
- 10) Select configure.
- 11) Change the server path to : mail03.safersys.org
- 12) Click OK
- 13) Click Exit.
- 14) Reboot the machine.
